Southwest Boulevard Merriam Lane Corridor Master Plan

Redeveloping
a Healthier,
Greener Corridor

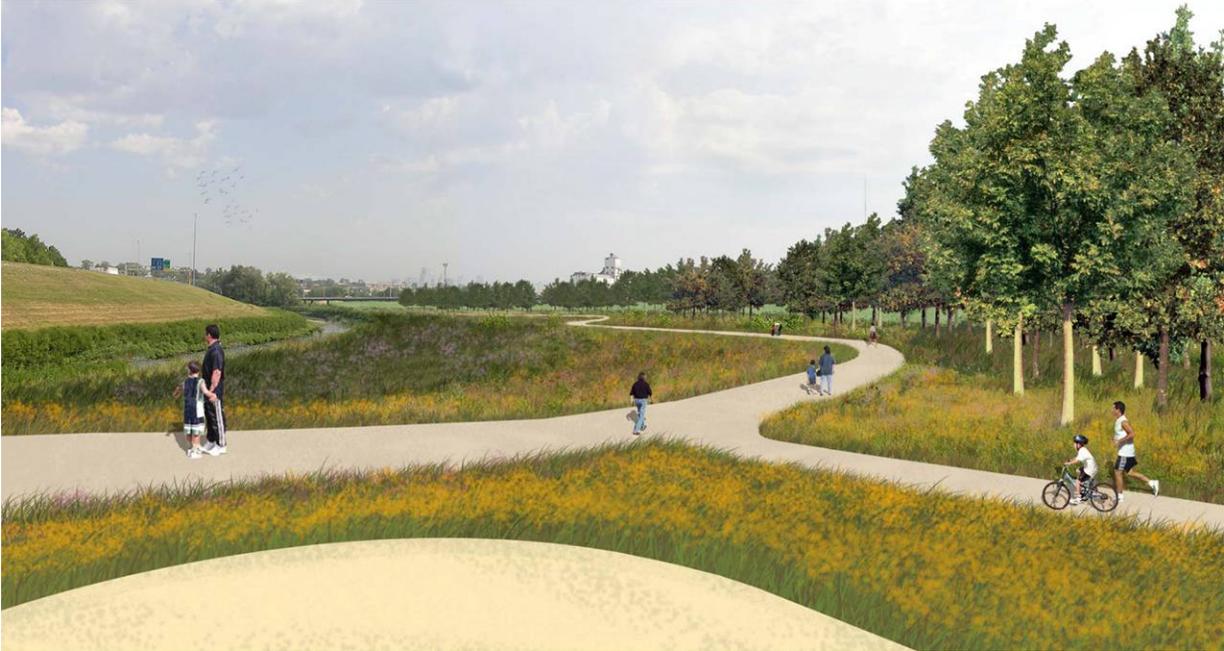
In an effort to assist the public in visualizing what the Environmental Enhancement Area can look like once it has become established, PBA provided perspective drawings of viewpoints at each end of the project area.

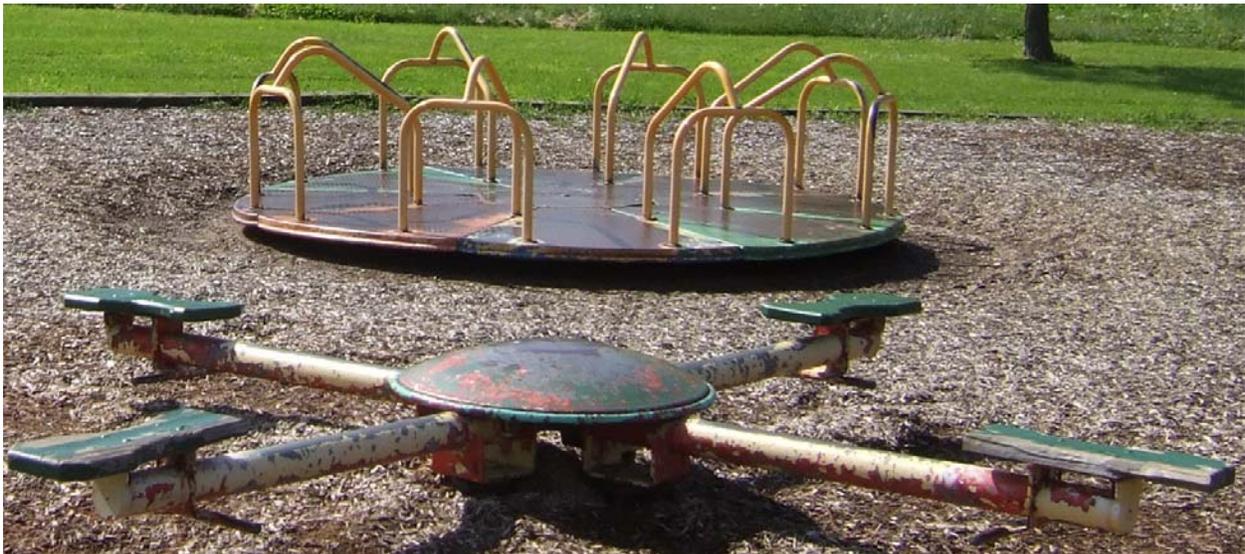
The playground area at Rosedale Park includes swings, spring animal riders, four-way teeter totter, merry-go-round, and a multi-use play structure featuring a chain ladder, climbing ladder, and two slides. Overall, every piece of this playground equipment is in need of repainting as faded and chipped paint is prevalent. Some equipment needs to be repaired and/or replaced, most notably the four-way teeter totter which has two seats broken nearly in half.

The playground equipment has significantly faded and chipped paint. In the lower right hand corner, a teeter totter seat is broken in half.

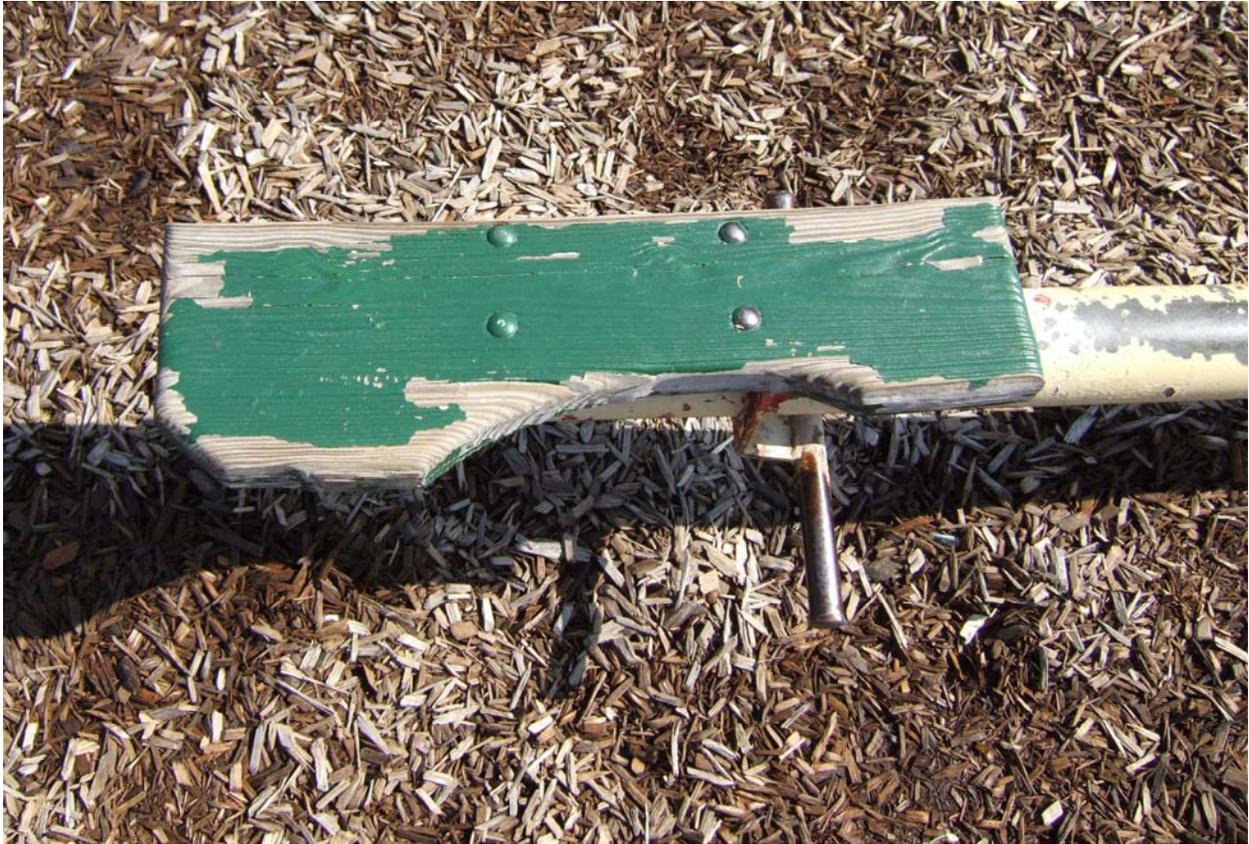
A closer view of the broken teeter totter seat and the woodchip playing surface.

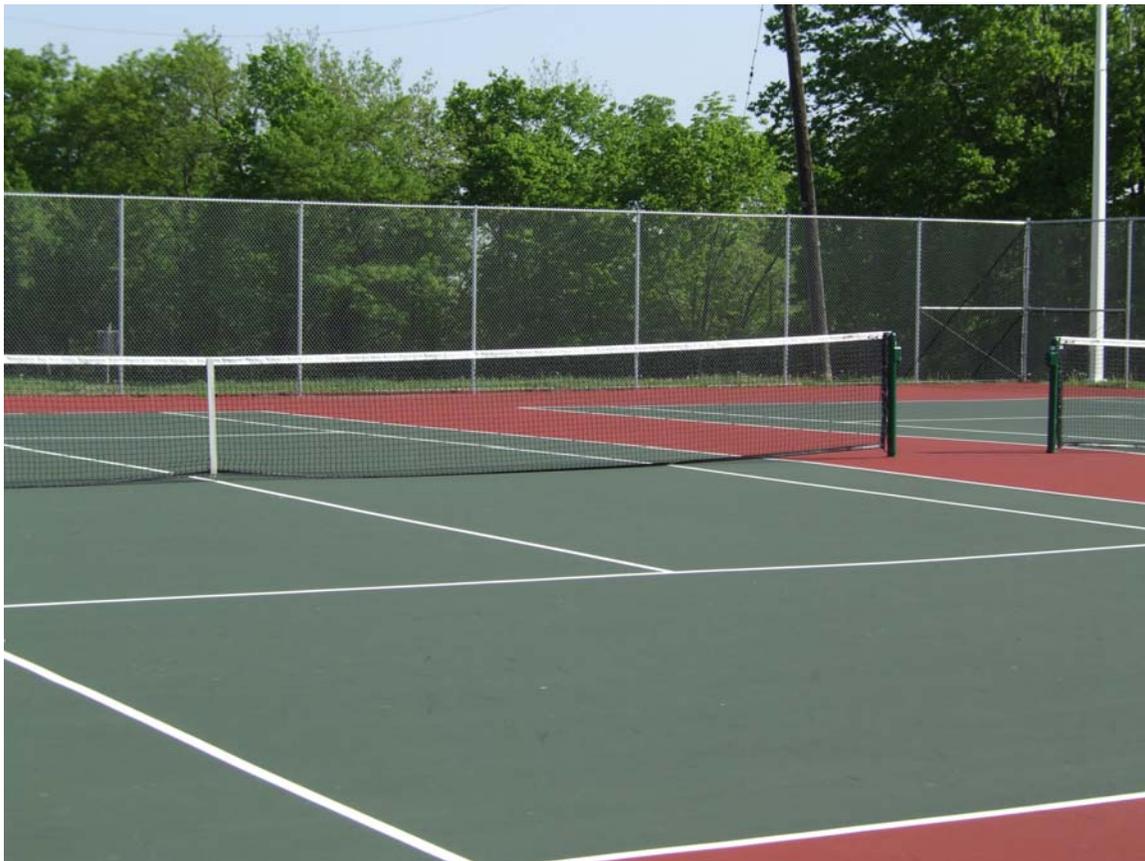
The two tennis courts at Rosedale Park were found to be in excellent condition. These courts appeared to have been recently installed. The surfaces were in excellent shape with no faded paint or cracked and uneven surfaces. In addition, the fencing surrounding the courts and the tennis nets looked new with no holes or damaged areas.

The tennis courts were in excellent condition with well marked lines and new equipment.

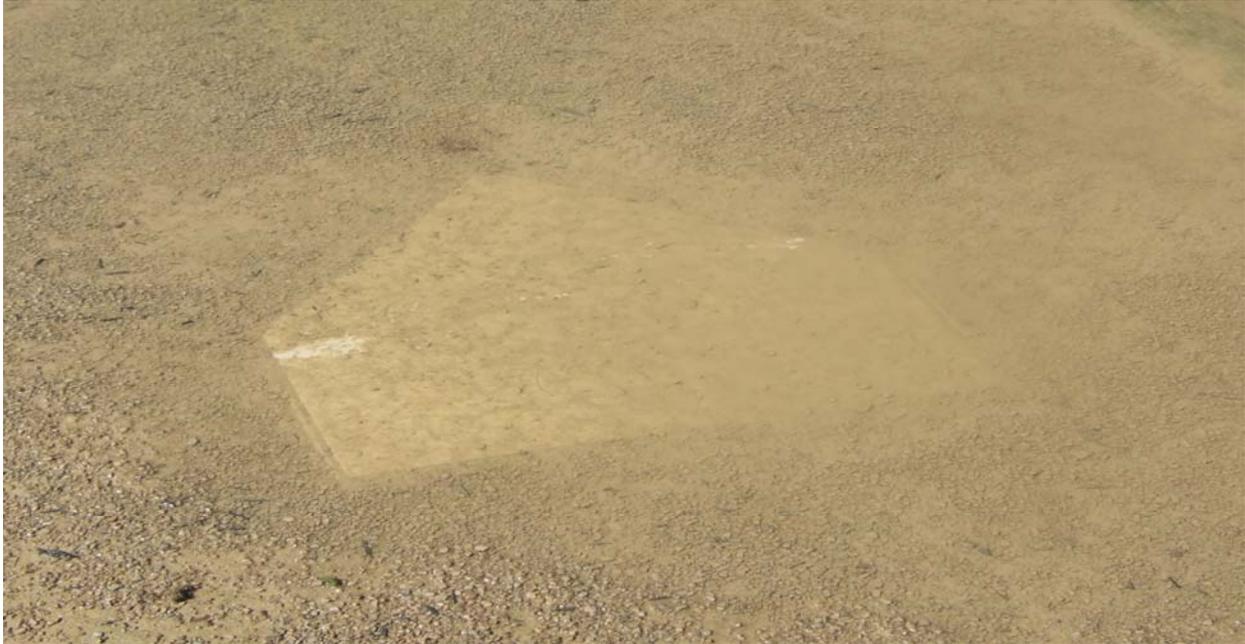
The west baseball diamond's home plate was underneath standing water.

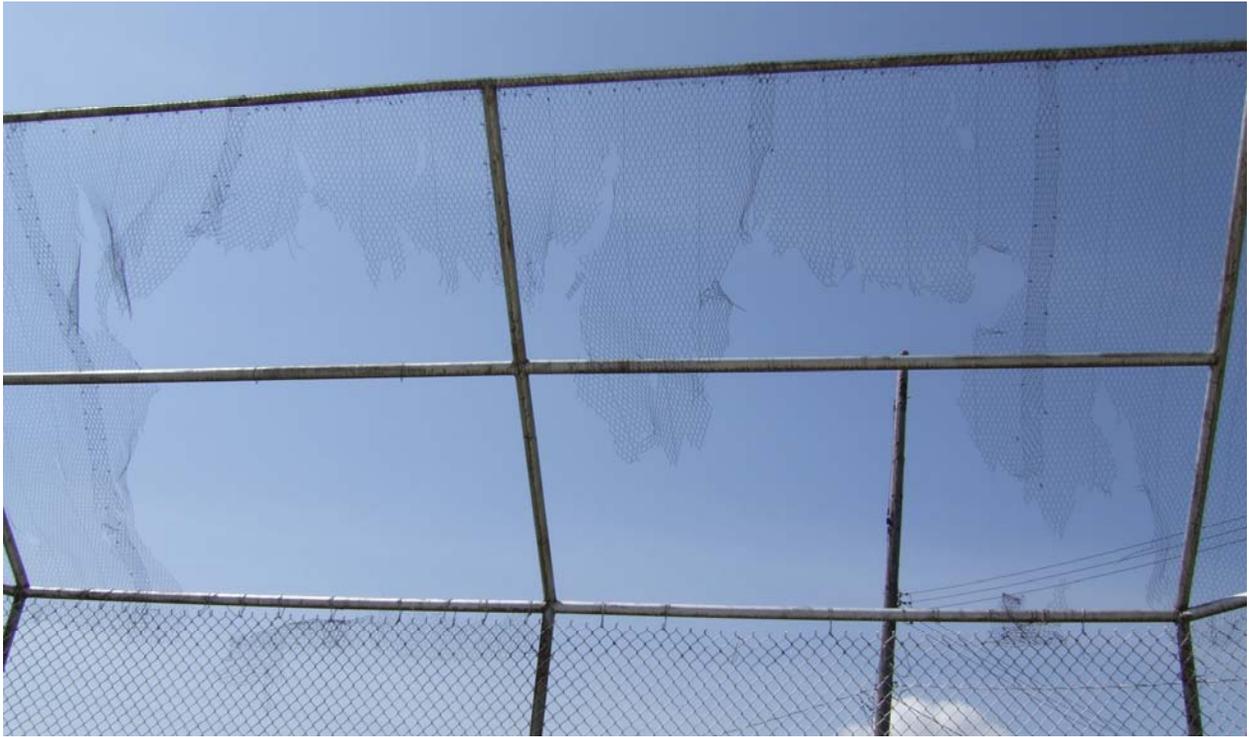
The east baseball field had large holes in the backstop overhang.

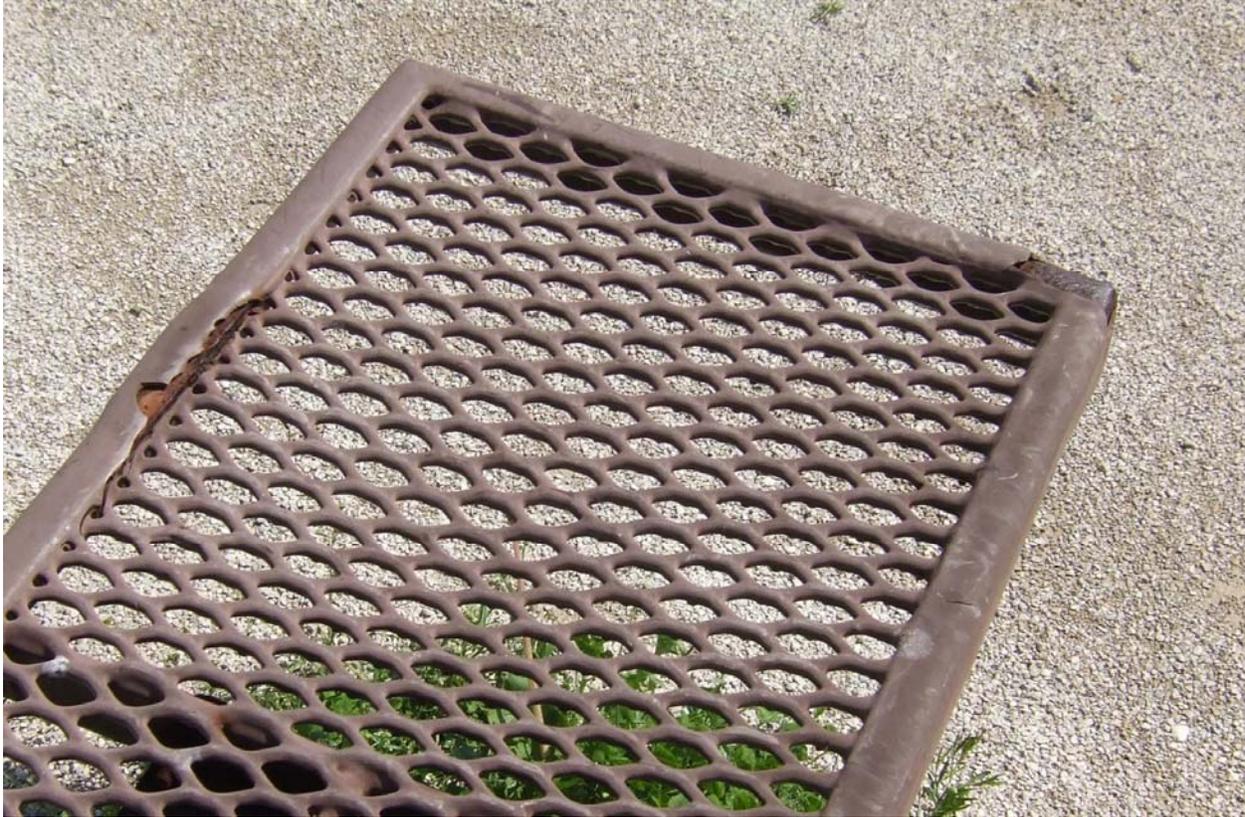
A dugout bench on the east baseball field had rust exposed by tears in its protective covering.

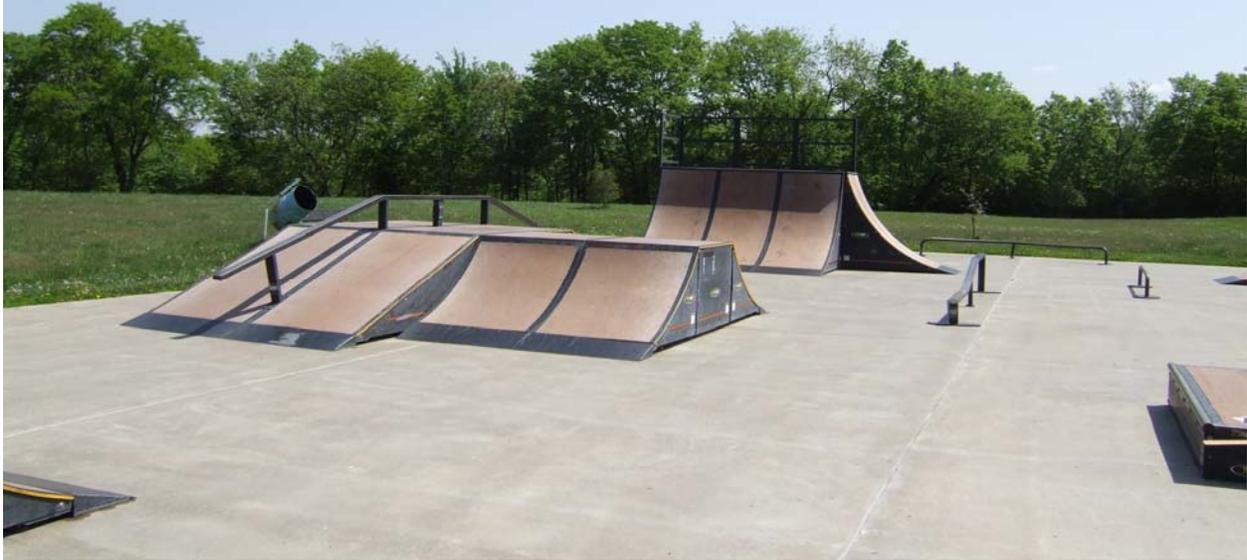
Rosedale Skate Park featured ramps in excellent condition. Close examination reveals graffiti in the form of arrows on the far ramp.

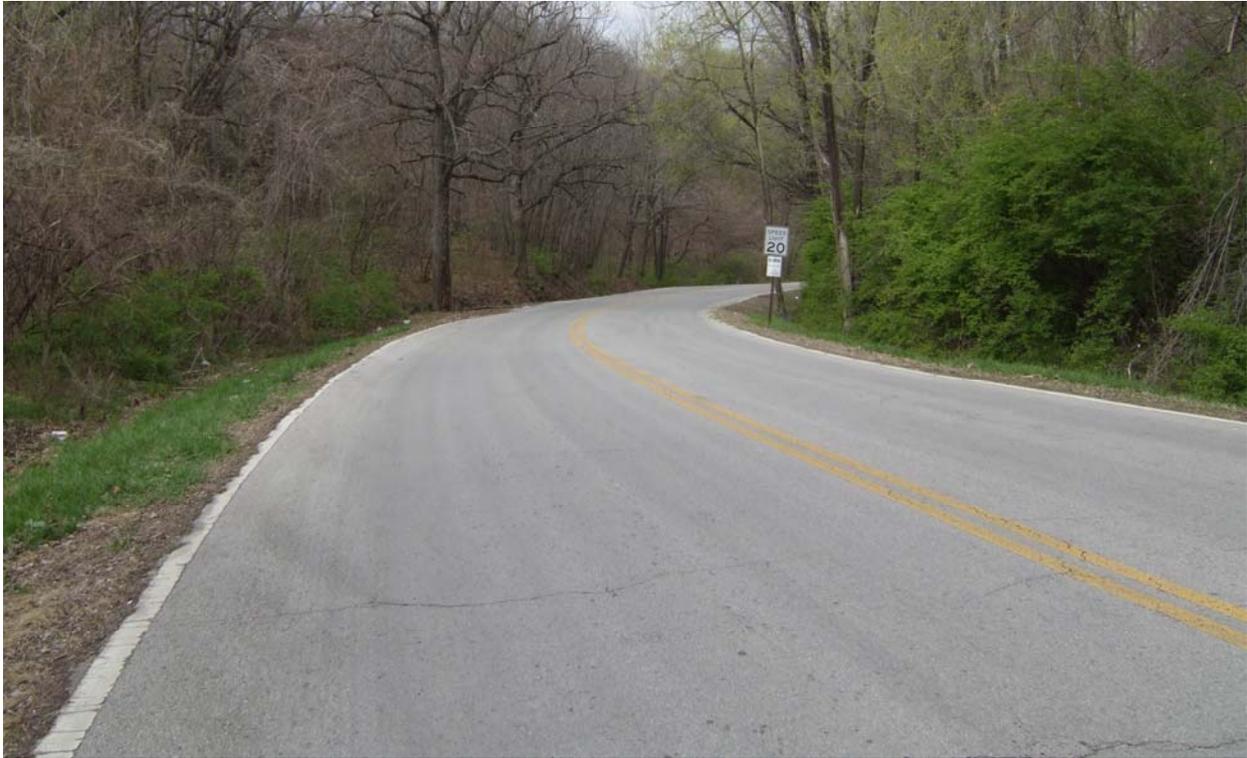
Rosedale Park Drive leads to the west side of the park but can be dangerous to pedestrians because it is curvy, has ditches on either shoulder, and lacks sidewalks.

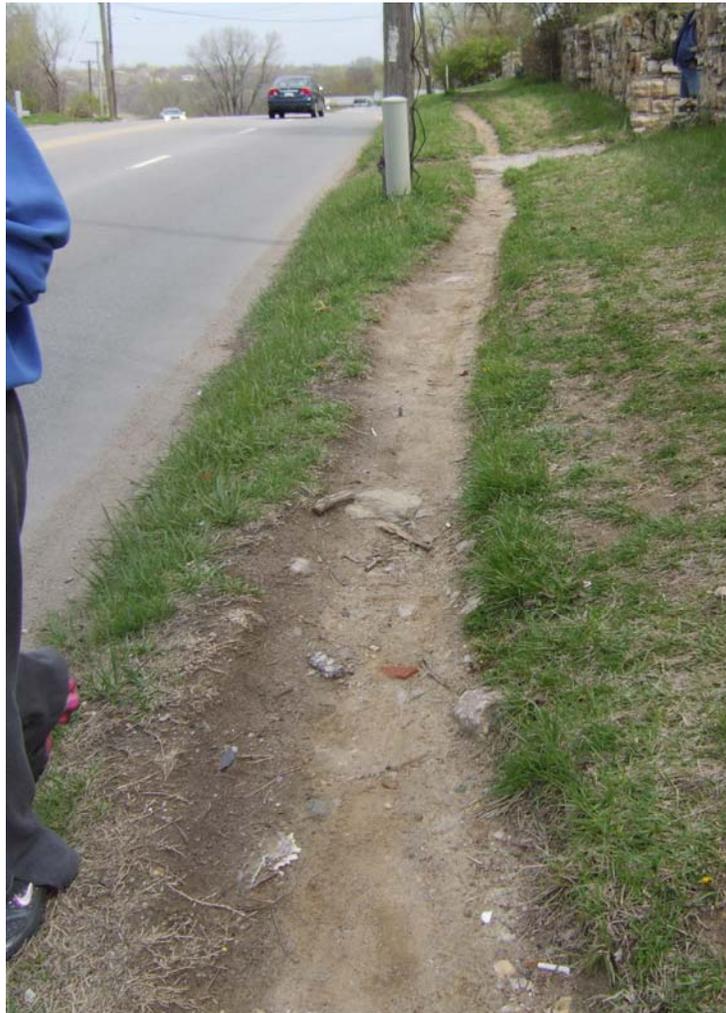
A dirt path was worn into the grass across the street from the main entrance to Rosedale Park. Cars are seen cresting the hill where pedestrians cross the street to the park.

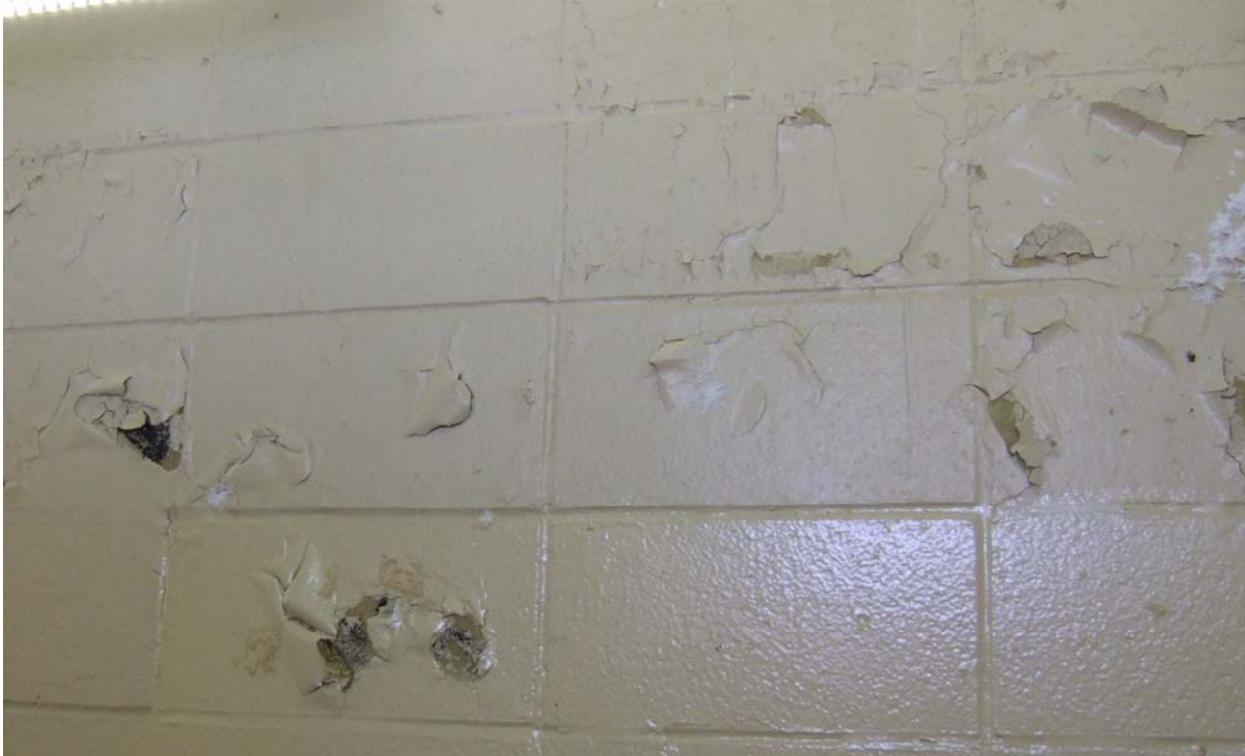
Paint in both restrooms is peeling away from the walls.

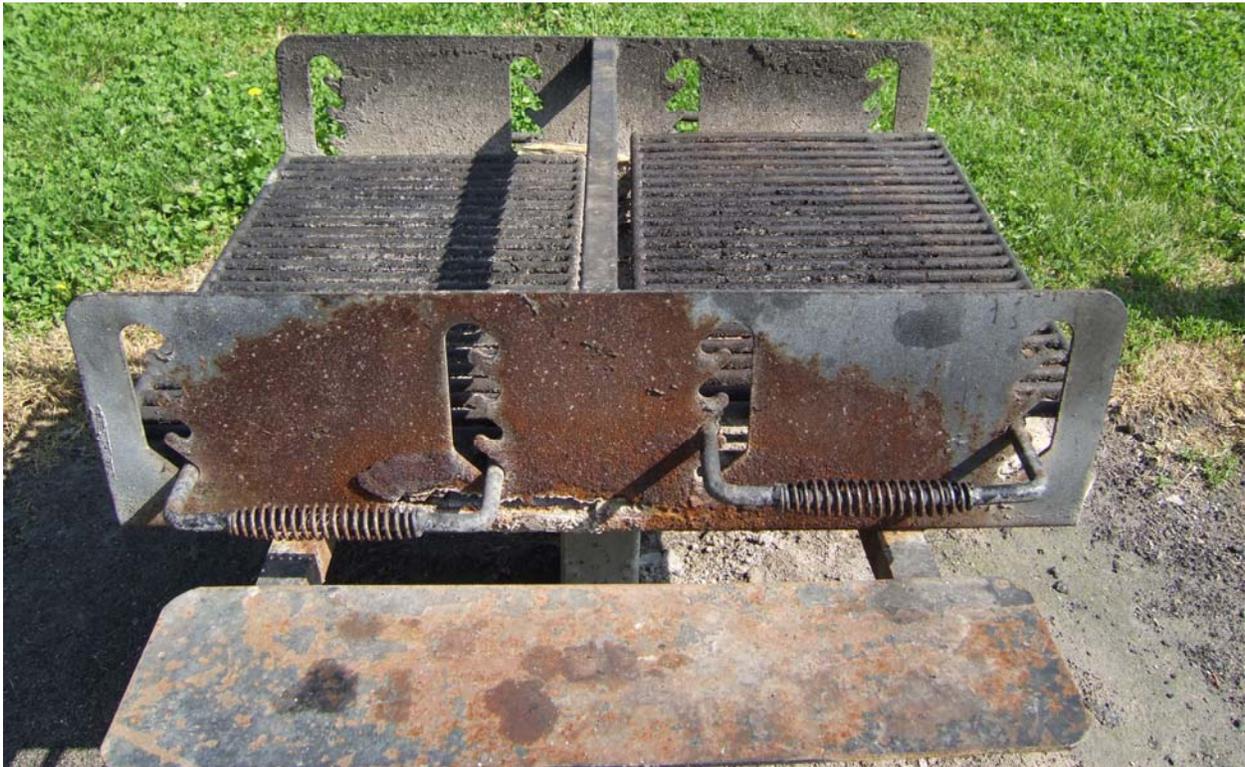
The barbecue grill is dirty and rusted. The ground underneath is muddy and covered in used coals.

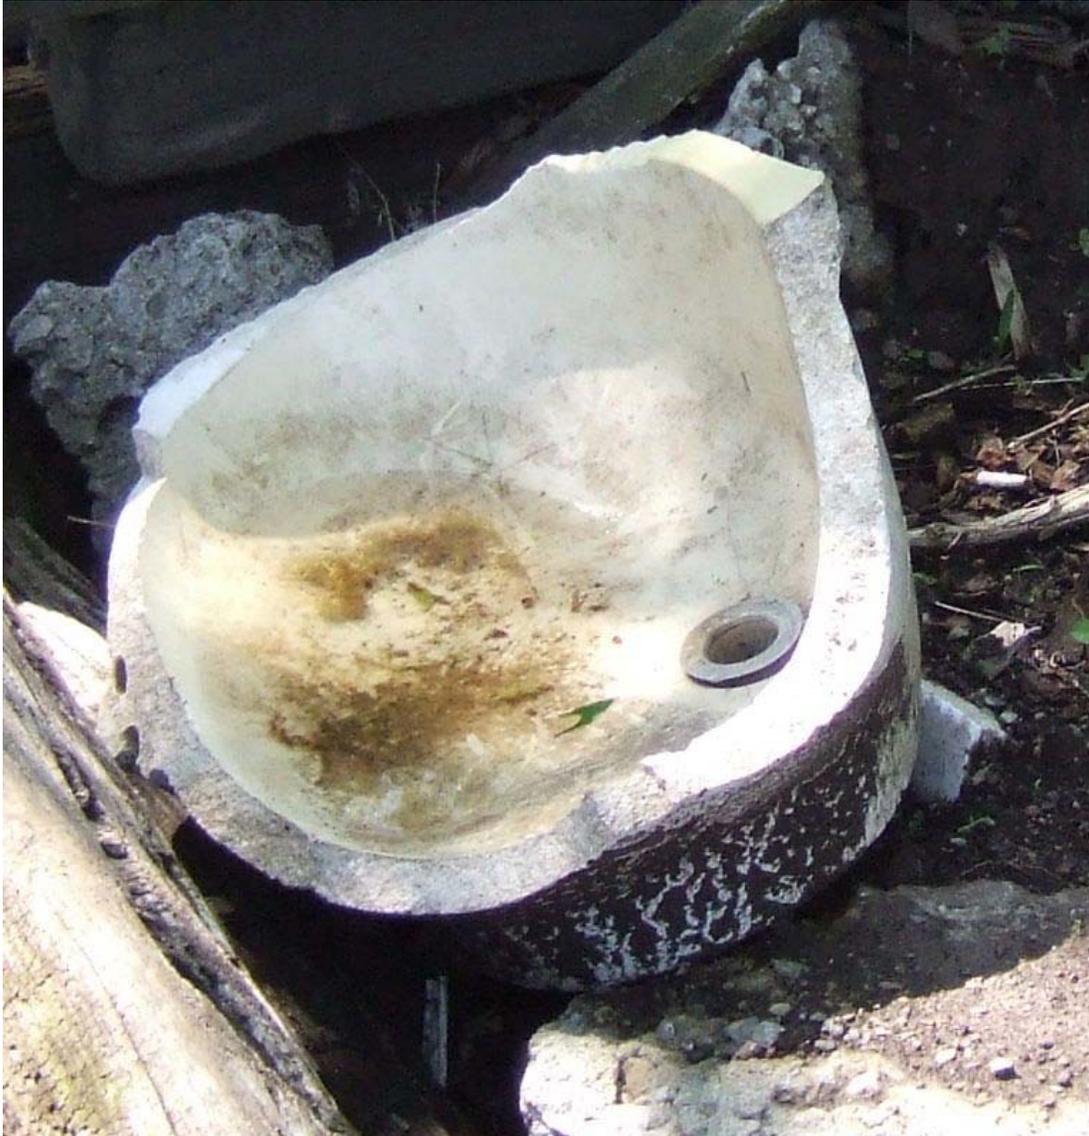
A broken sink was found lying amongst rocks and tree stumps on the disc golf course.

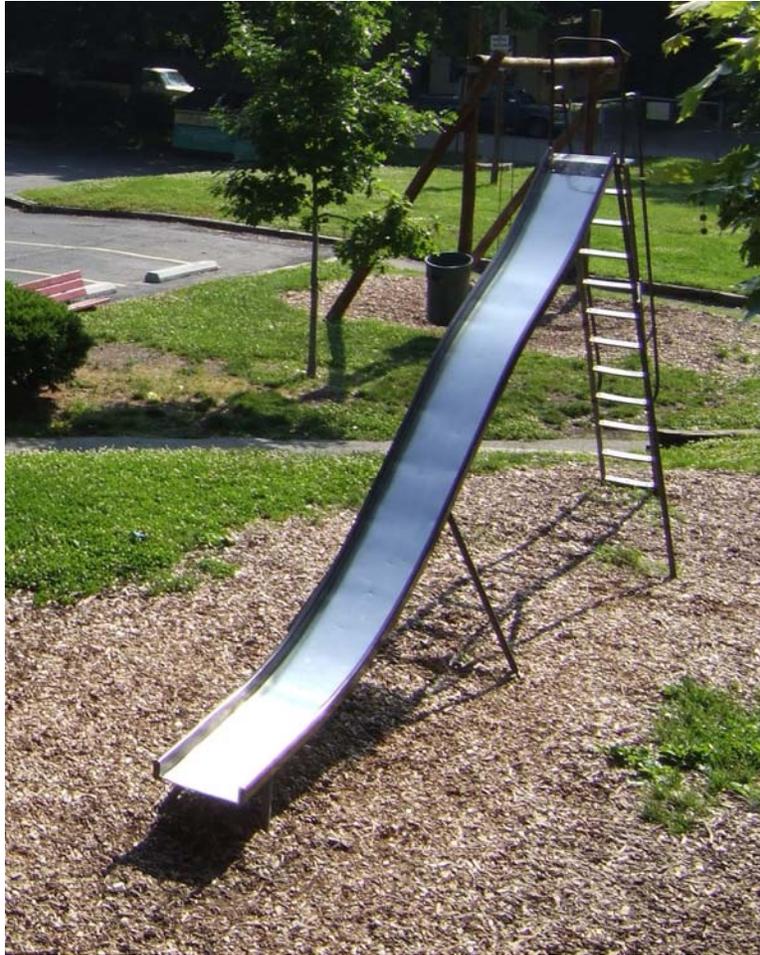
The ladder to the large slide did not possess an adequate fall zone, especially behind the ladder, even though it was very tall and did not have side barriers to prevent falls. In addition, grass can be seen growing through the woodchips which are of an inadequate depth to sufficiently prevent injury from falls.

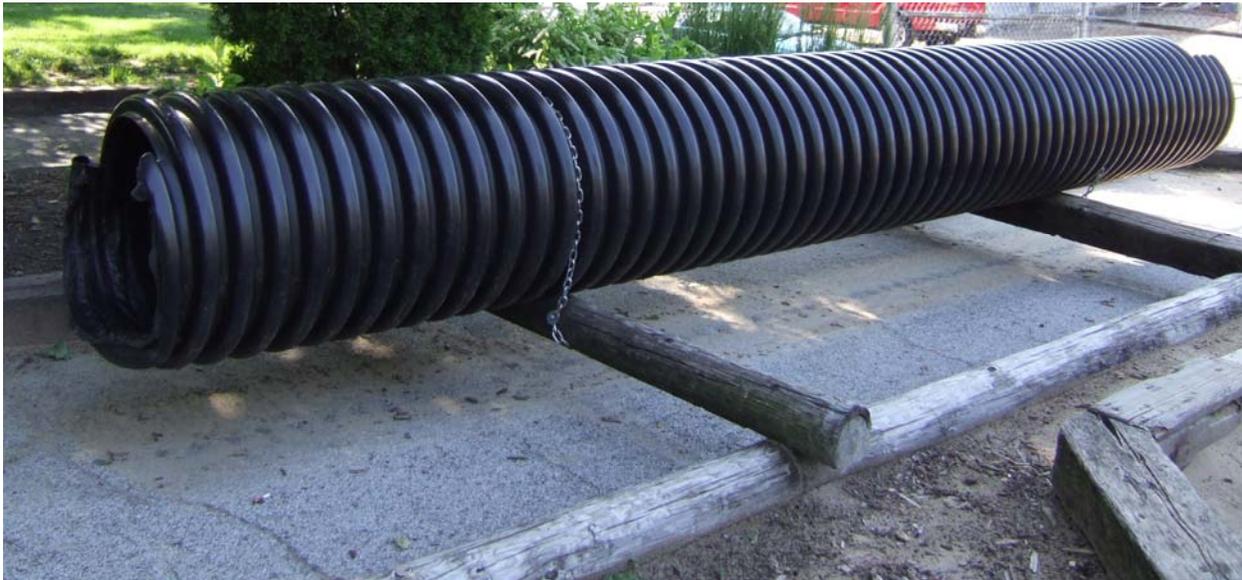
A tunnel was located over asphalt which could cause injury to a child who may fall climbing in or out.

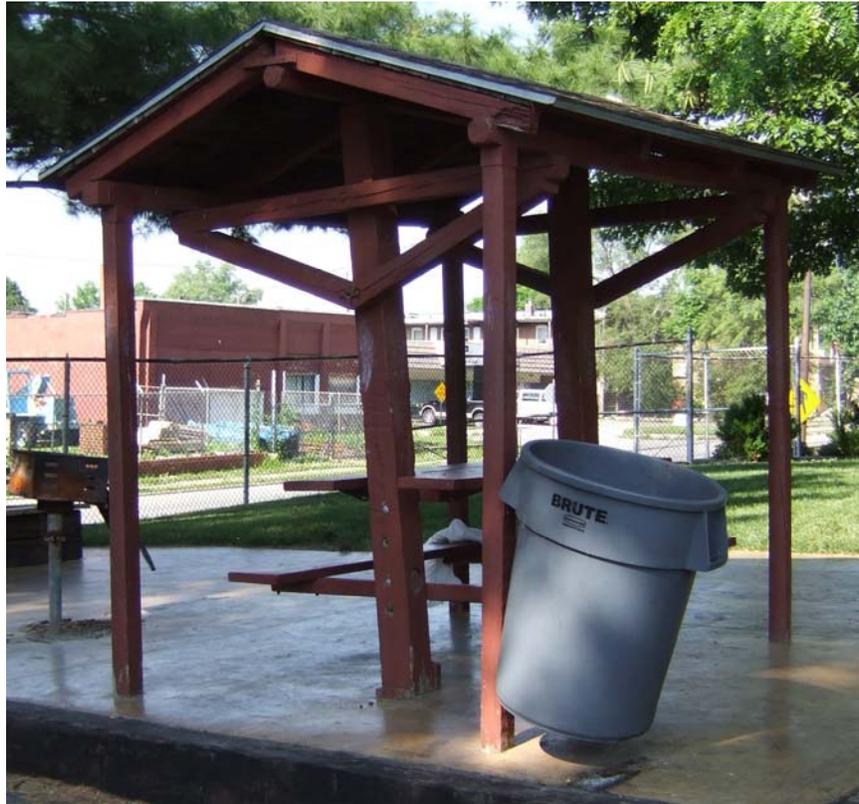
The shelter house contained a built-in picnic table but needs repainted due to faded and chipped paint.

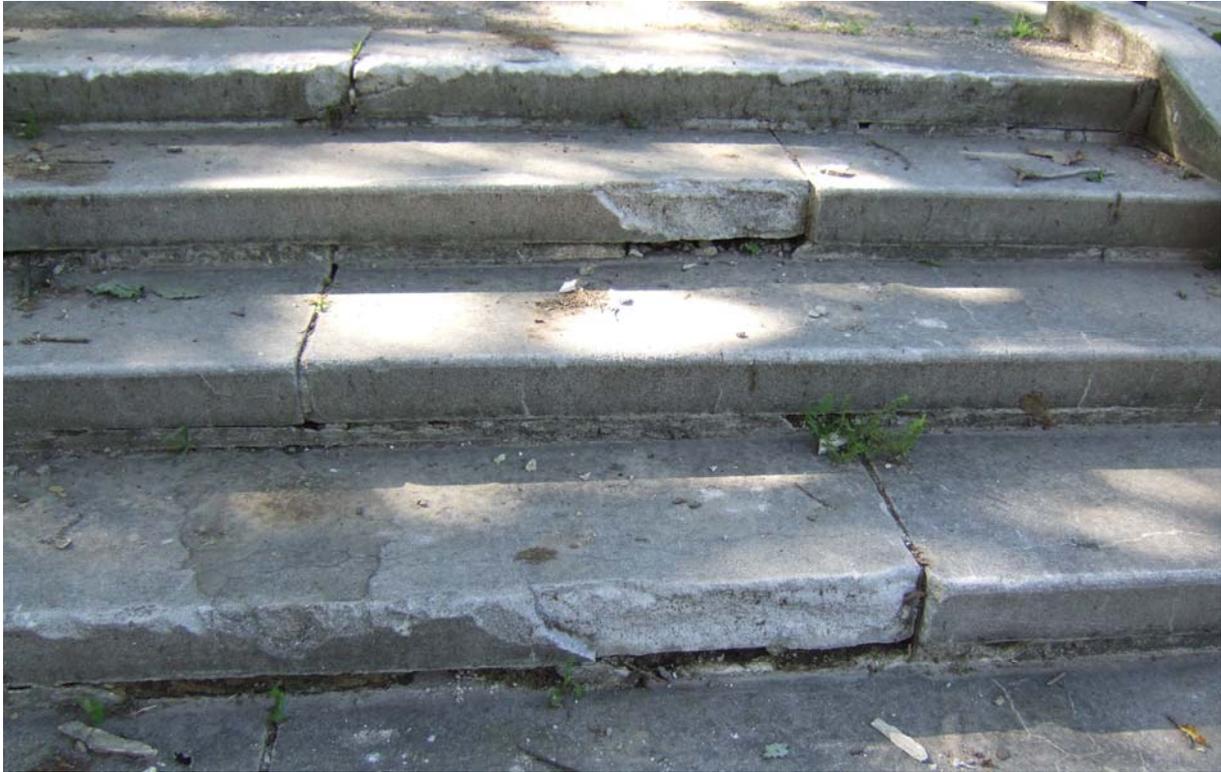
These stairs were in poor condition with many broken and chipped steps.

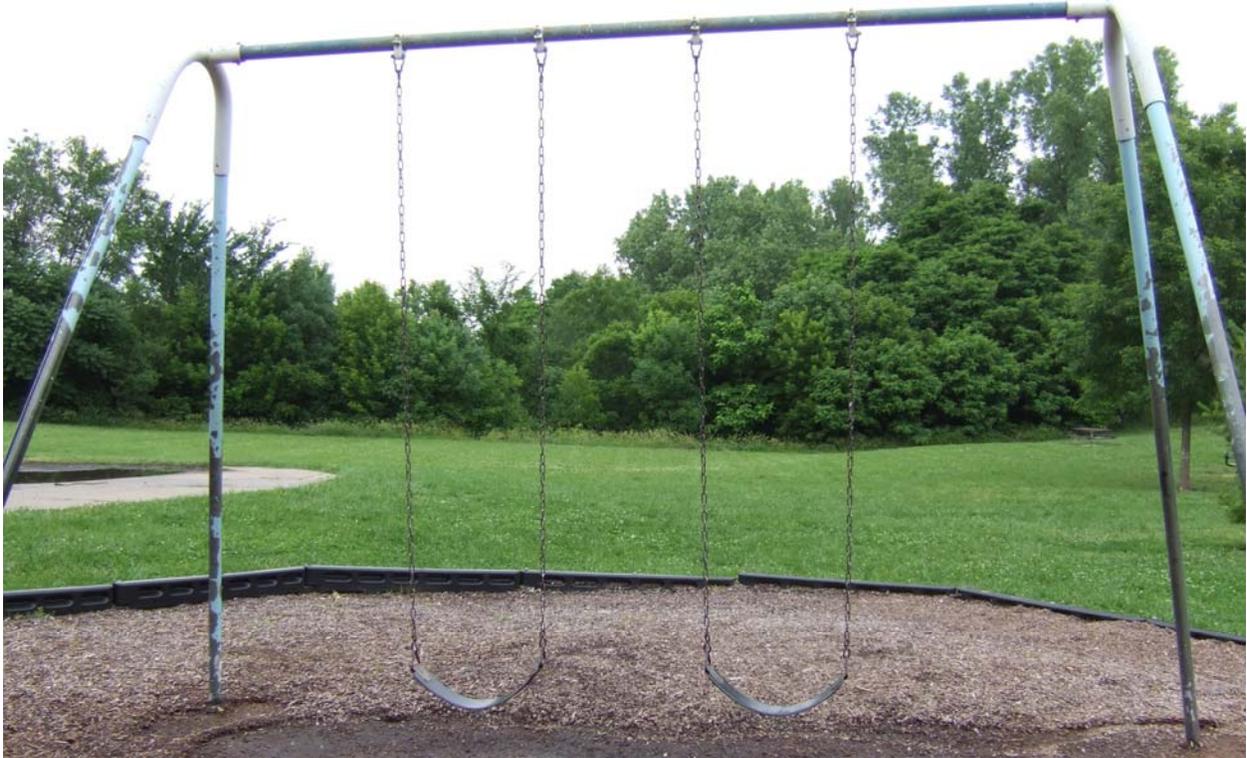
Although the swings comply with most safety recommendations, the support structure had lots of peeling paint.

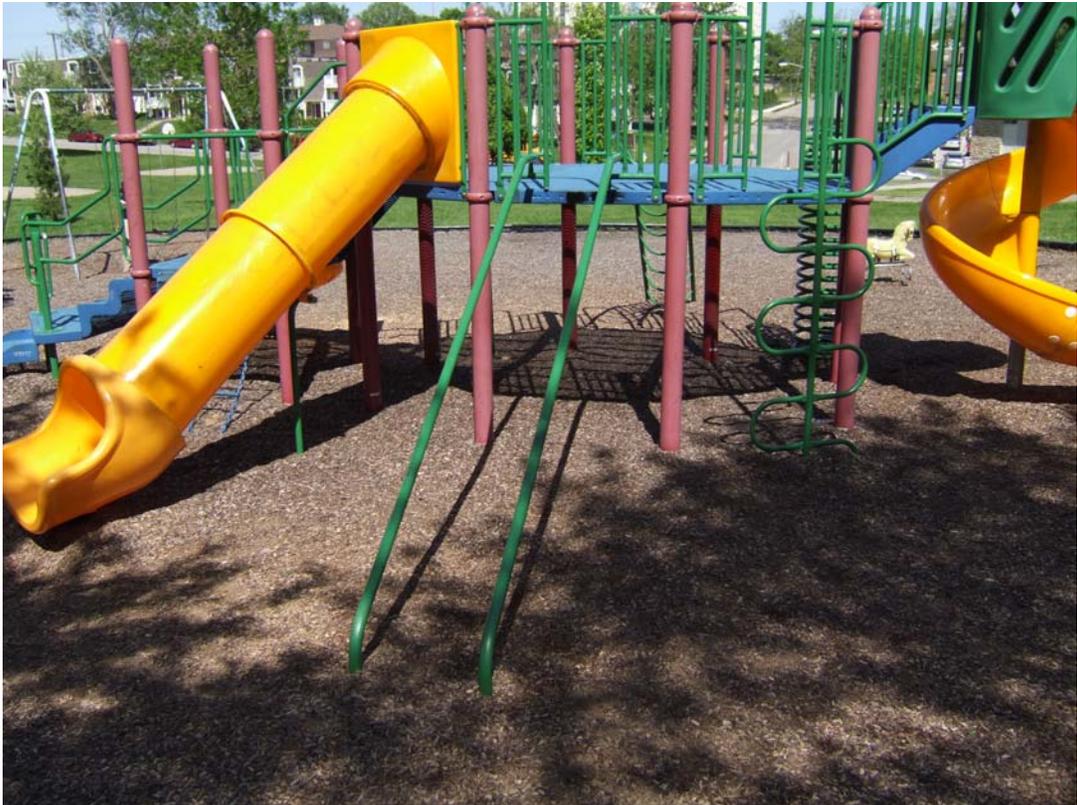
The multi-use play structure had faded and chipped paint as well as graffiti inside the tube slide.

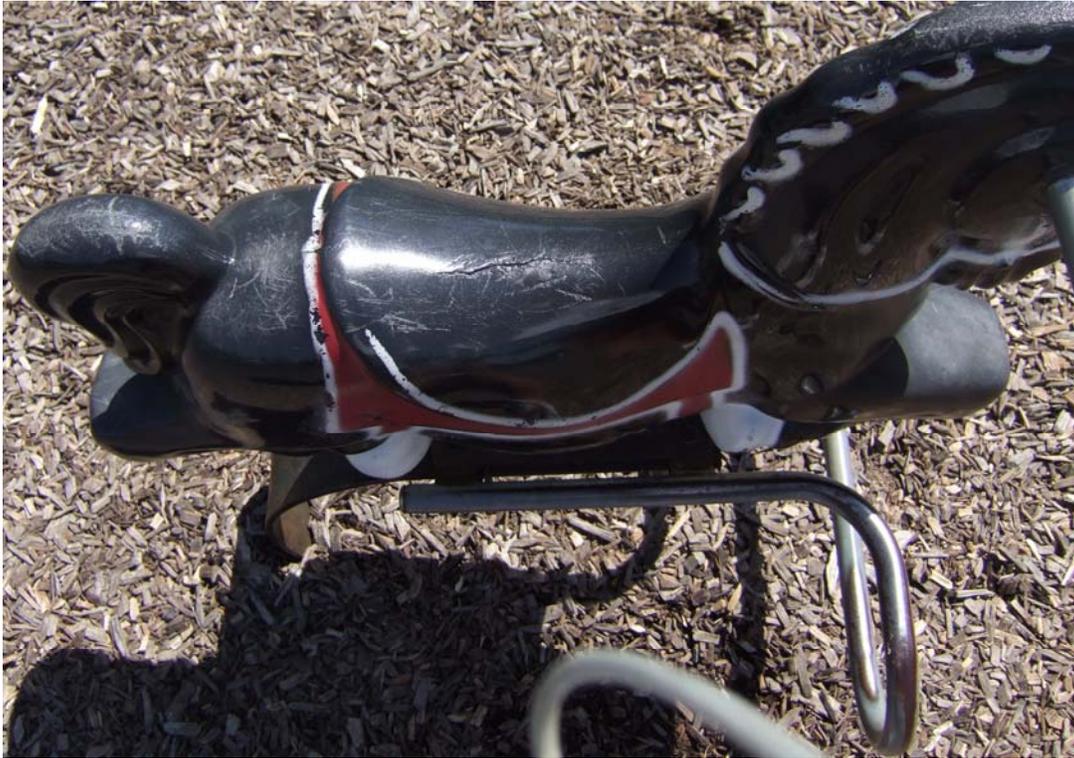
The spring animal riders had large scratches in their surface. In addition, their foot rests may pose a risk of head entrapment. One can also view the woodchip surfacing material.

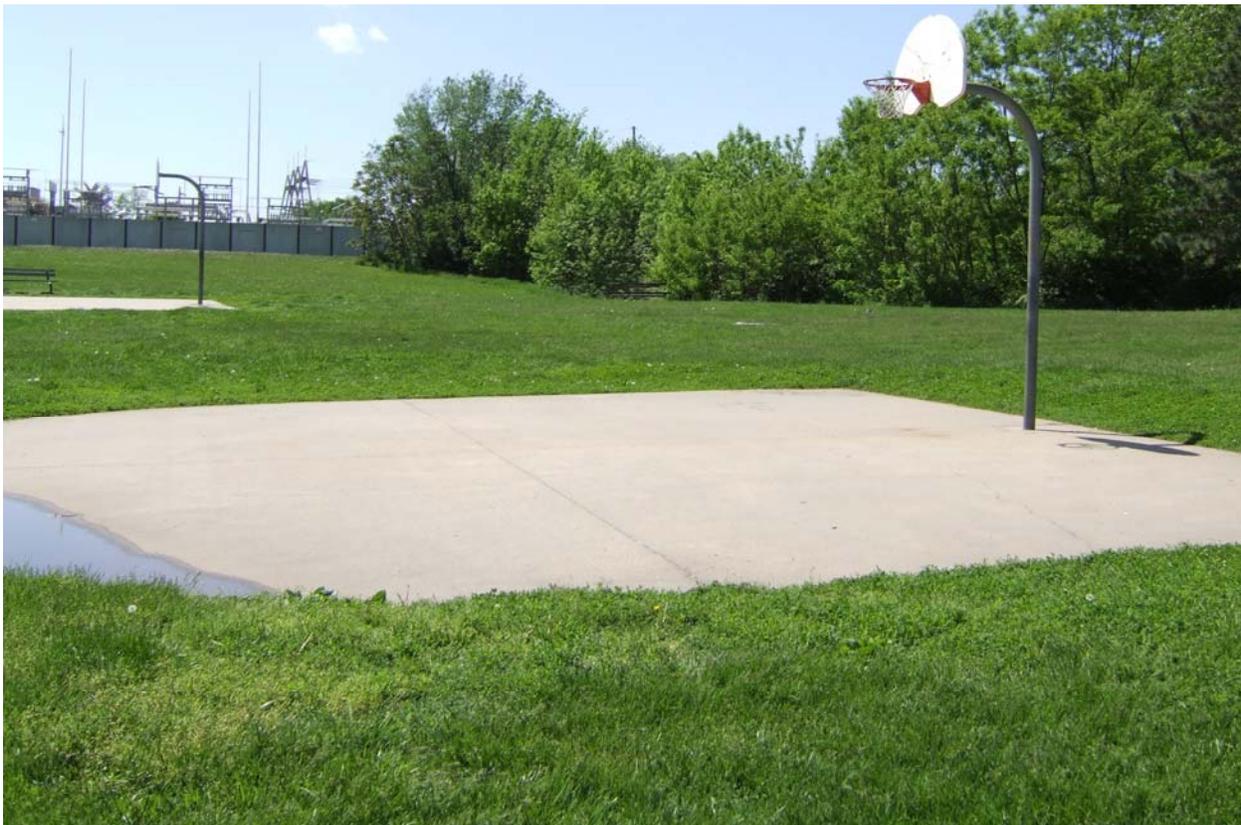
The east basketball court has a drainage problem which leaves standing water on the court's edge, chipped paint on the backboard, and graffiti on the playing surface.

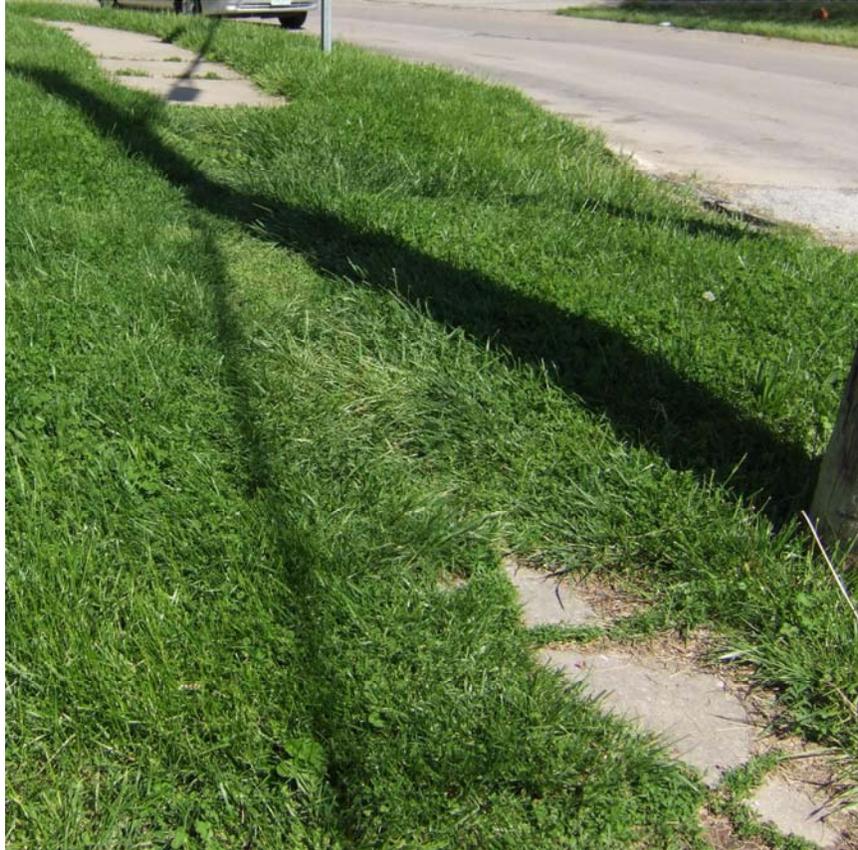
The sidewalk bordering the south side of the park began in excellent condition but quickly changed to a very poor condition.

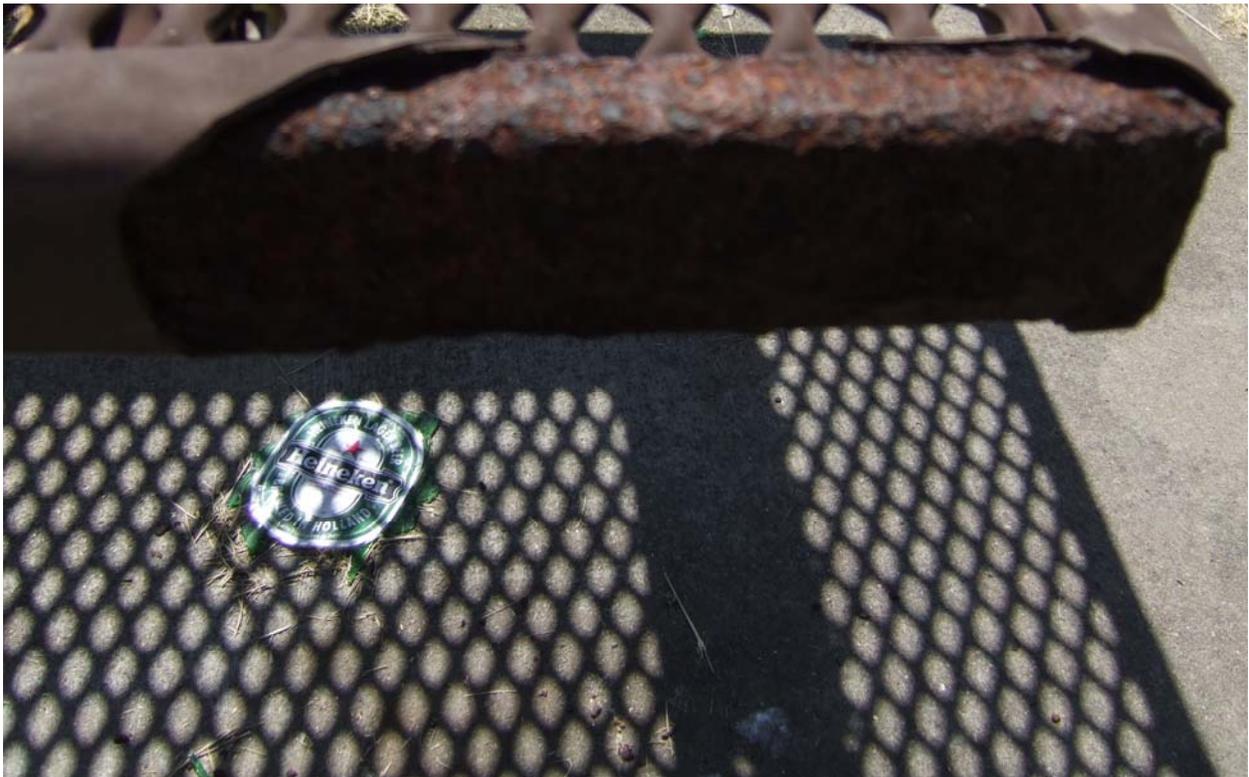
Rust was visible on a picnic table which has lost a large portion of its protective coating. A broken beer bottle was also found underneath the table.

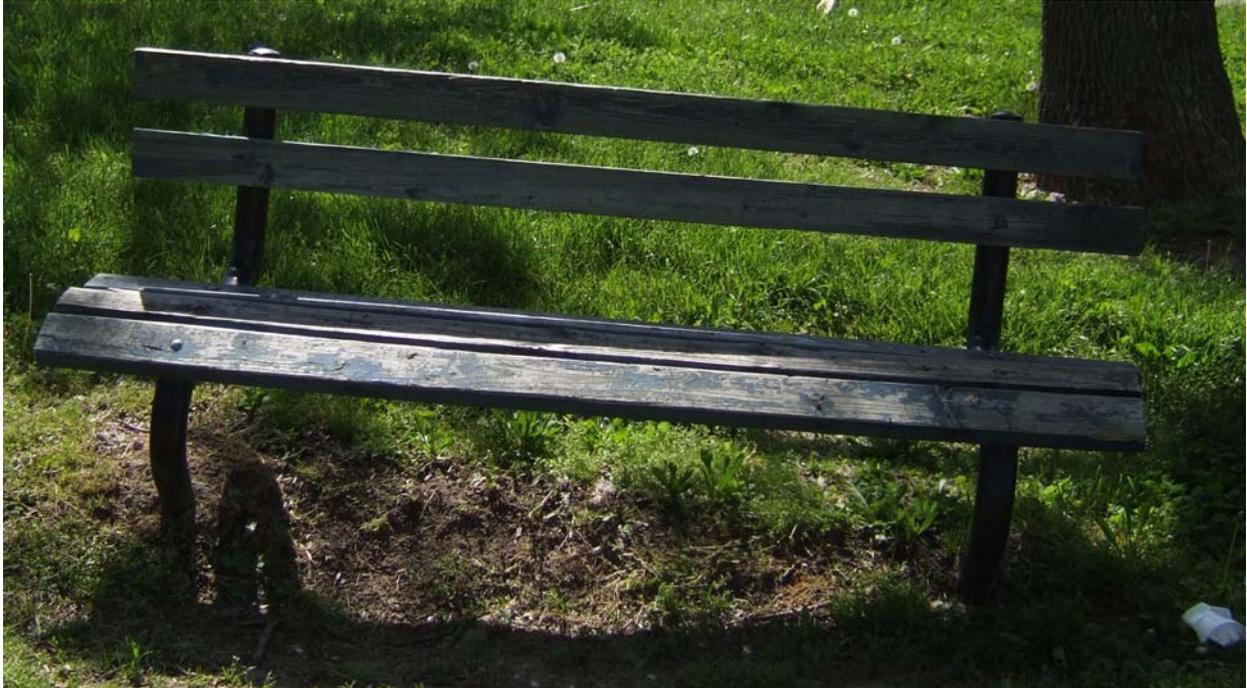
This bench had significantly chipped paint and the seat sat at an angle.

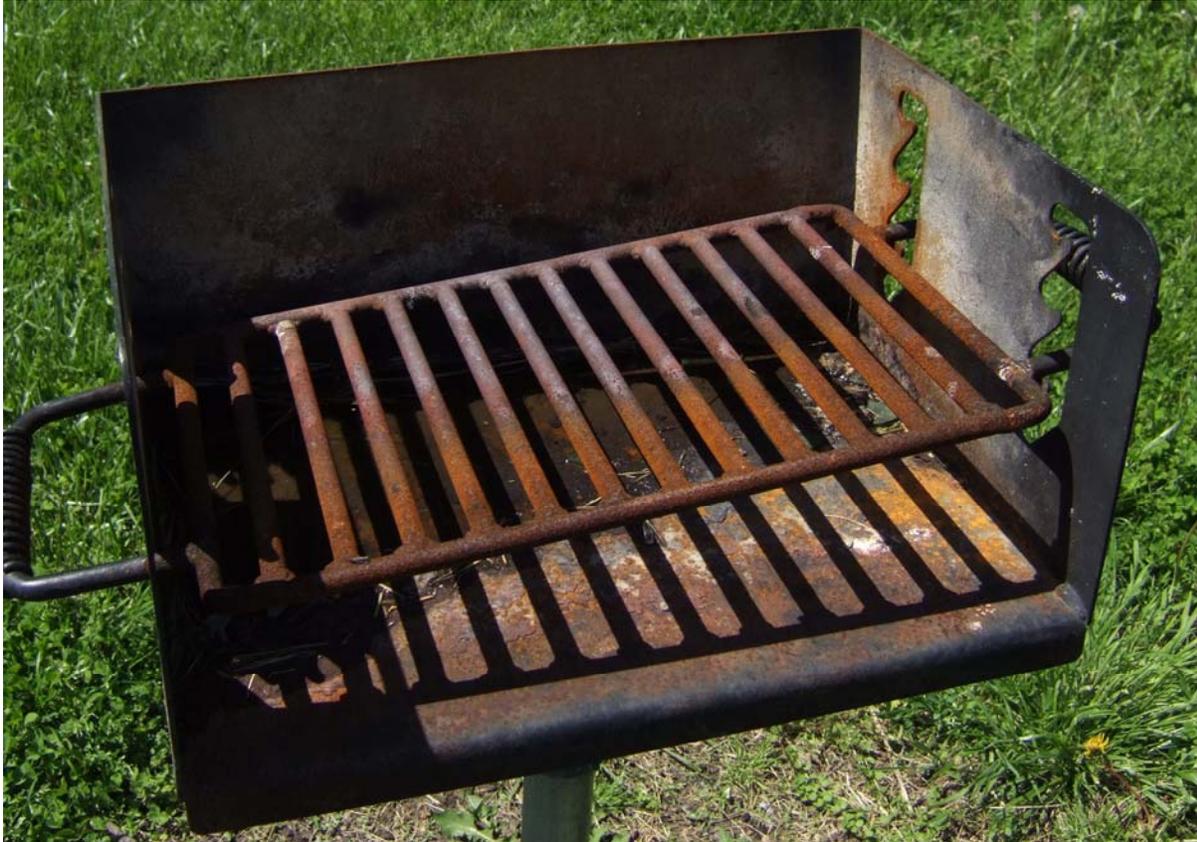
This grill was severely rusted and had standing water within its coal reservoir.
