Southwest Boulevard Merriam Lane Corridor Master Plan

Redeveloping
a Healthier,
Greener Corridor

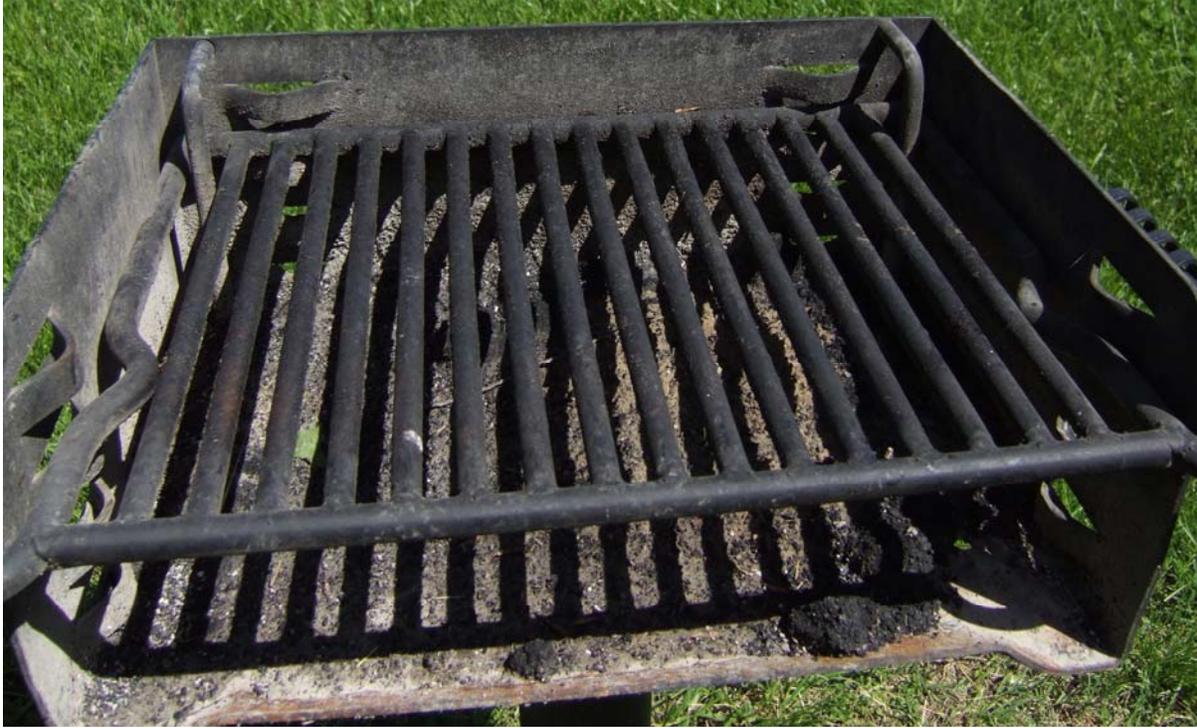
This grill's coal reservoir was filled with old coals, sticks, and trash. In addition, the grill rack had food burnt to its surface.
